## THE BRIEF

The Guardtech Group Service Department were tasked with conducting a full Validation on a CleanCube Maxi portable cleanroom, including testing of: Air Change Rates, Pres-

# VALIDATION CASE STUDY

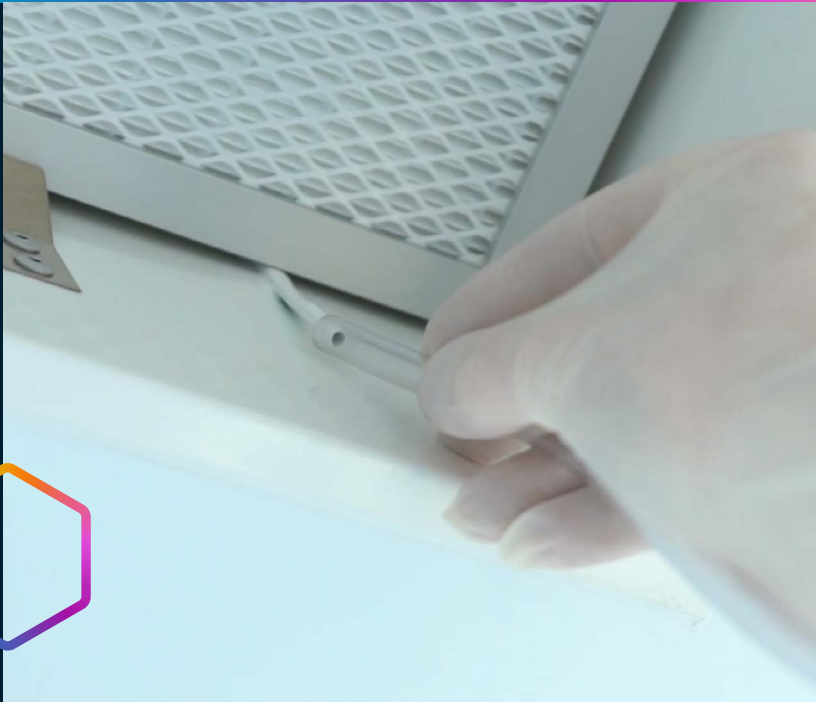
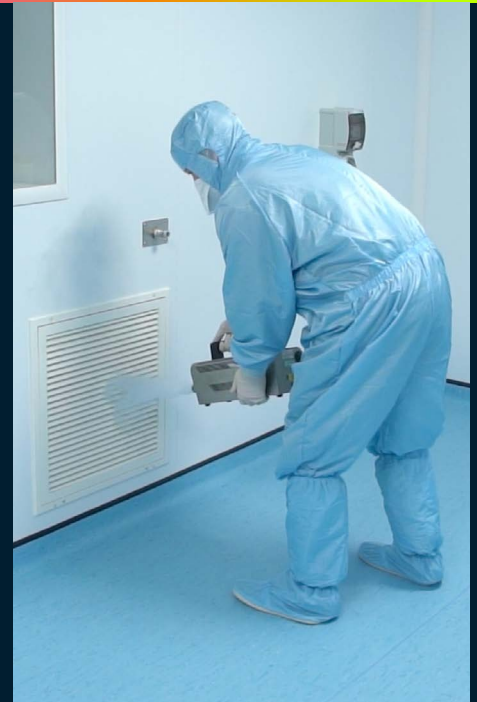
Figure 11 – Humidity Monitoring positions at bench height (plan view)

**Temperature Levels:** The temperature was measured at a minimum of one location for each temperature-con-

trolled zone (see diagram below). Each sensor was placed at a designated location at work-level height using a calibrated Temperature Sensor. After sufficient time was allowed for the sensor to stabilise, the Guardtech Engineers recorded temperature readings at each location. Measurements were performed as appropriate for the purpose of the application and the measurement time was at least five minutes, with one value recorded at least every minute. The average temperature reading from each room was above the minimum permissible temperature value and so a pass was recorded.

**Humidity Levels:** The humidity was measured at a minimum of one location for each humidity-controlled zone. Each sensor was placed at the designated location at work-level height using a calibrated humidity sensor. After sufficient time was allowed for the sensor to stabilise, the humidity reading at each location was recorded. Measurements were performed as appropriate for the purpose of the application and the measurement time was at least five minutes, with one value recorded at least every minute. The average reading from each room was above the minimum permissible humidity value and so the CleanCube was deemed to have passed.
